# Sound solutions for the food and drink industries

Reducing noise in food and drink manufacturing

## **HSG232 (Second edition, published 2013)**

This book gives examples of simple, cost-effective ways of reducing the risk of hearing damage to workers in the food and drink industries. It contains 60 case studies showing how companies have found successful solutions to problems created by high noise levels.

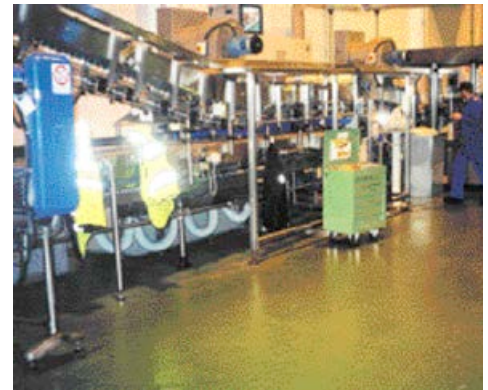
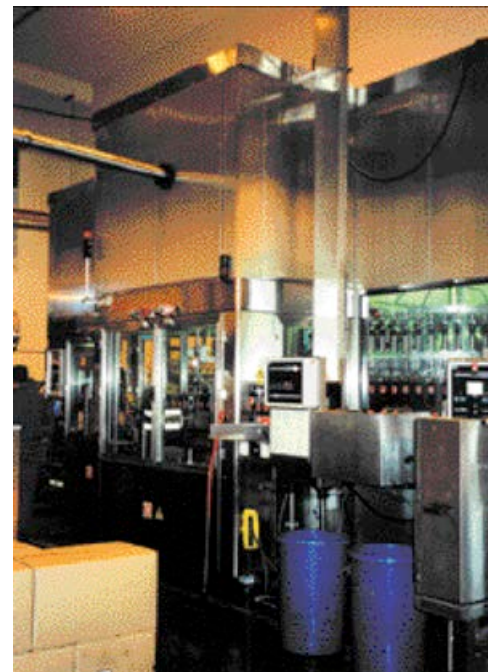
*Solution: new bottling line*

On the new line, the rinser-filler-capper machine was enclosed and there was less use of stainless-steel, which helped reduce the reverberant noise. The company also installed the line in a production hall with high ceilings to reduce the reverberant noise levels.

The company ordered a new bottling line and, with the Noise Regulations in mind, specified that the noise level at the employees' positions should be no greater than 80 dB when operating. They liaised with the manufacturers and purchased a machine with reduced noise levels.

- The noise levels produced by the new bottling line were below 80 dB.
- The layout of the line made cleaning easier.
- The number of raised work platforms on the new line was reduced, which led to a reduction in accidents from slips, trips and falls.
- The new line was more efficient.

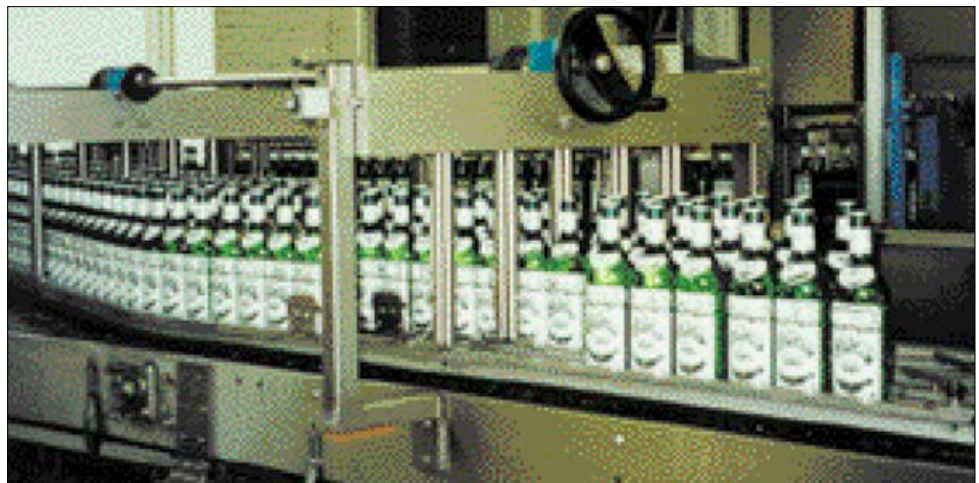
*Solution: new variable-speed conveyor with adjustable guide-rails*

A noise survey identified the high noise levels. The company purchased a new design of conveyor in which the various chains moved at different speeds in relation to the number of bottles on the line and their progress through the machines.

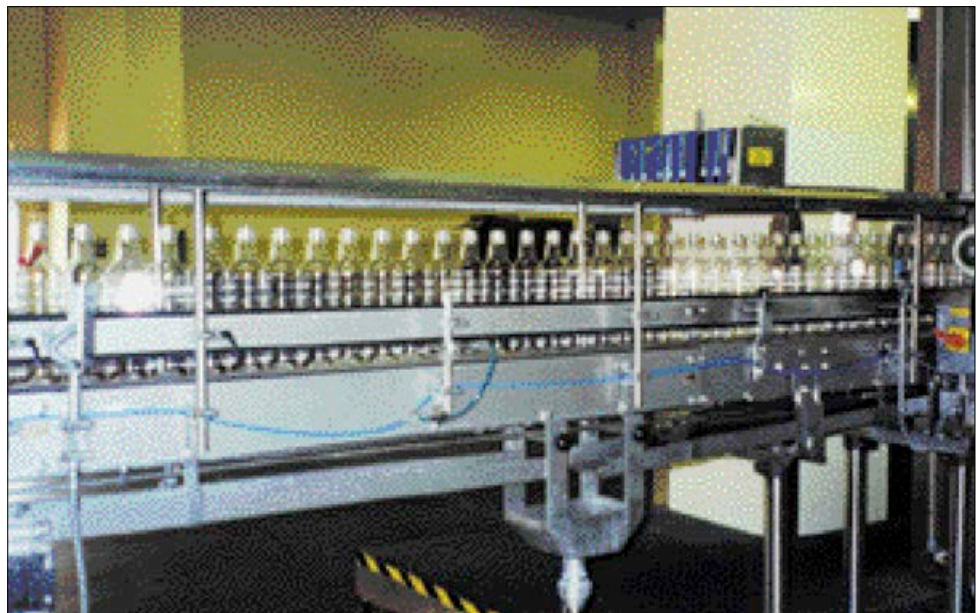
*Solution: new machine fitted with guide-rails in laner mechanism*

As part of bringing in a new machine, the laner mechanisms were changed to include guide-rails that moved the bottles into lanes. This change resulted in no additional cost.

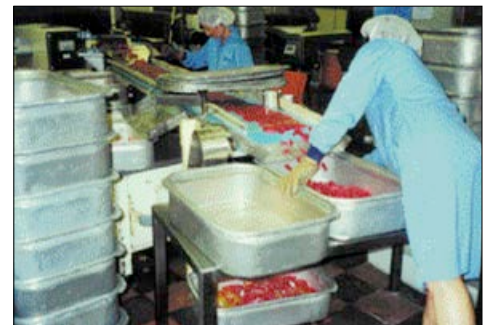
*Problem: sweets dropping into metal trays causing noise*

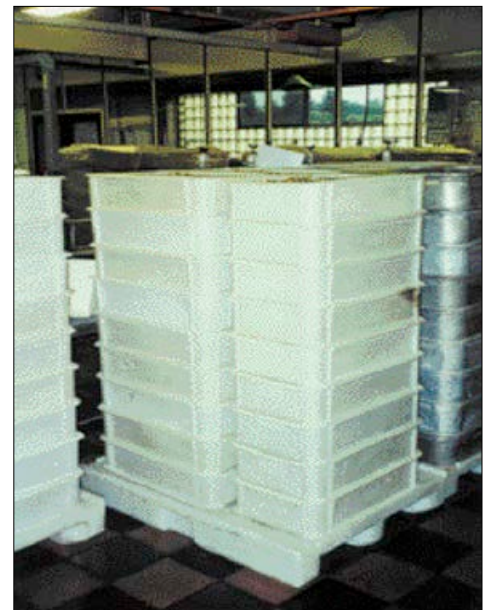
*Solution: plastic trays now used to reduce noise*

The company replaced the metal trays with trays made from high-density plastic.

- Noise levels in this section were reduced to 84–85 dB.
- The trays were lighter for the operators to handle.
- Risk of metal contamination was eliminated.

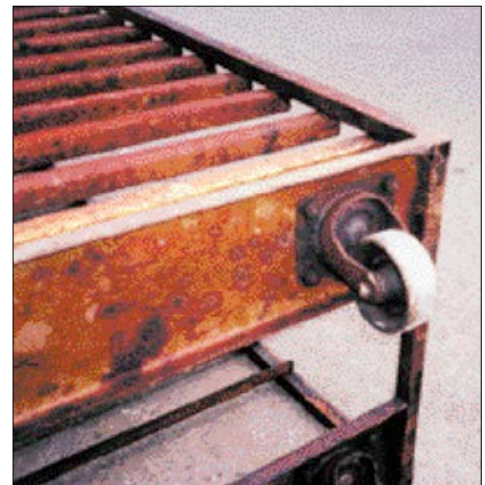
*Problem: rack fitted with original metal wheels*

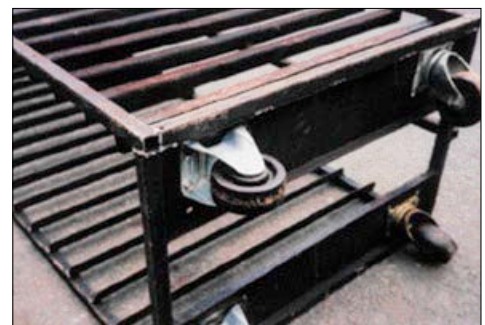
*Solution: rack with new phenolic wheels*

The company replaced the metal wheels on the baking racks with phenolic resin wheels.

- The intermittent noise levels within this area were reduced to 86–92 dB.

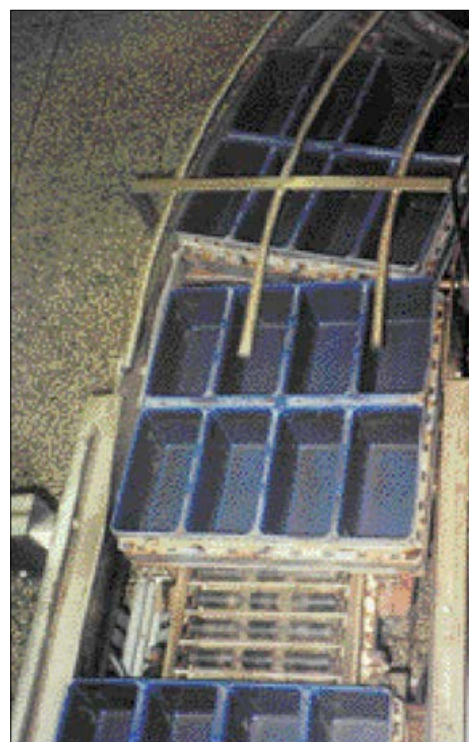
*Solution: new conveyor fitted with freely rotating rollers (visible between blue tins)*

When tins reached a flow-control stop point, the chain or slat conveyors continued to run, driving the tins into each other and causing them to vibrate and rattle on conveyor guides. This produced continuous noise levels typically in excess of 90 dB and much higher short-term peaks, depending on operating conditions.

- General noise levels from this source were reduced to below 85 dB.
- There were significant reductions in tin and conveyor wear.

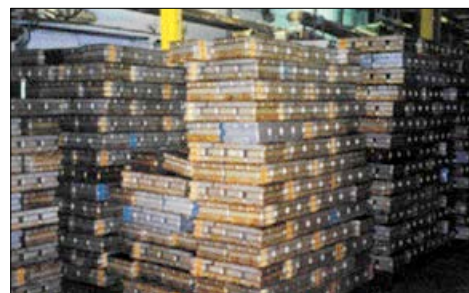
*Problem: manually stacked tins*

The operation also presented manual handling risks and resulted in excessive wear and damage to tins and conveyors.

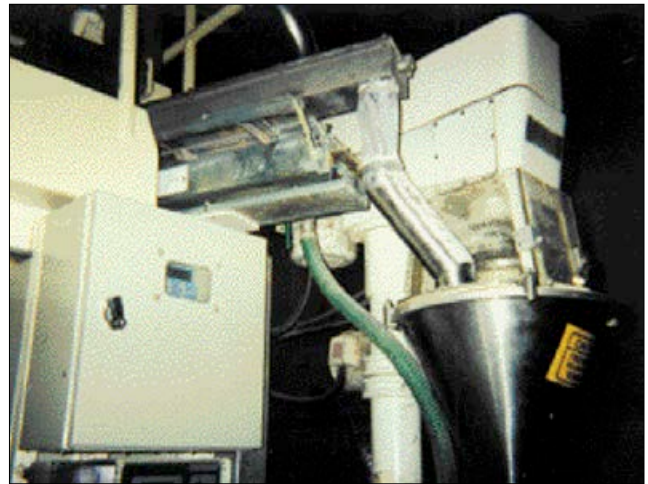
*Solution: new design of horizontal powder-feeder*

The combination of solutions resulted in such a decrease in noise levels that the company removed the hearing protection zoning from this area. The company was also able to simplify the guarding design to make both operation and servicing easier. Over a 12-hour shift, with the new arrangement, operators were exposed to only 80 dB.

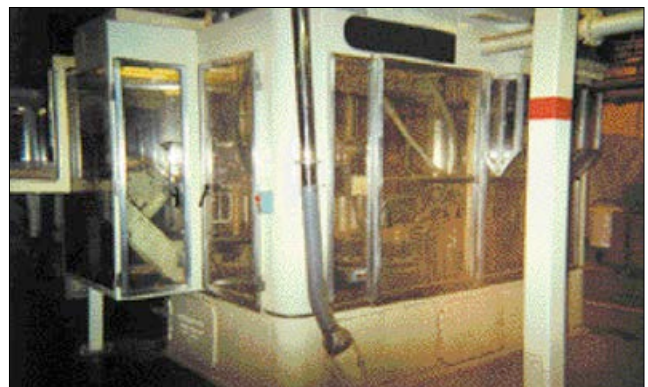
*Solution: new sealed enclosure for cup-filler machine*

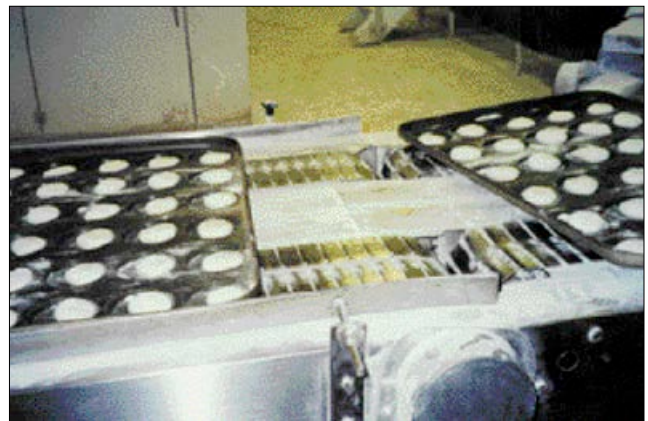
*Problem: original metal track conveyor*

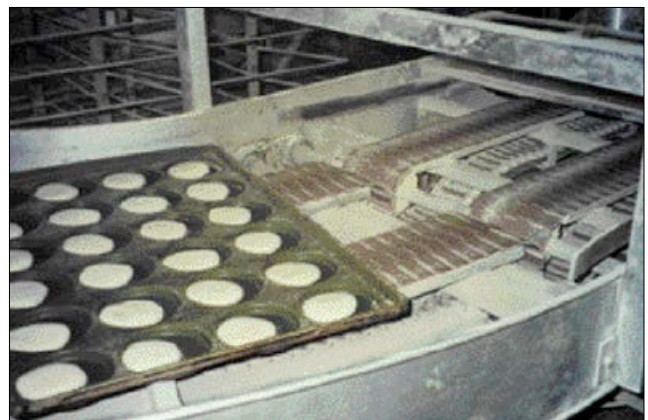
*Solution: new plastic tracking on conveyor*

The metal tracking on the conveyor was replaced with plastic (polyurethane) tracking, which was less noisy when it came into contact with metal.

- The plastic tracking reduced the noise level in the area to 87 dB.
- Unlike the metal tracks, the plastic ones did not wear to produce sharp edges and therefore cut injuries to workers were reduced.
- The plastic tracks were cheaper to replace than the metal ones.
- The plastic tracks were easier to maintain.

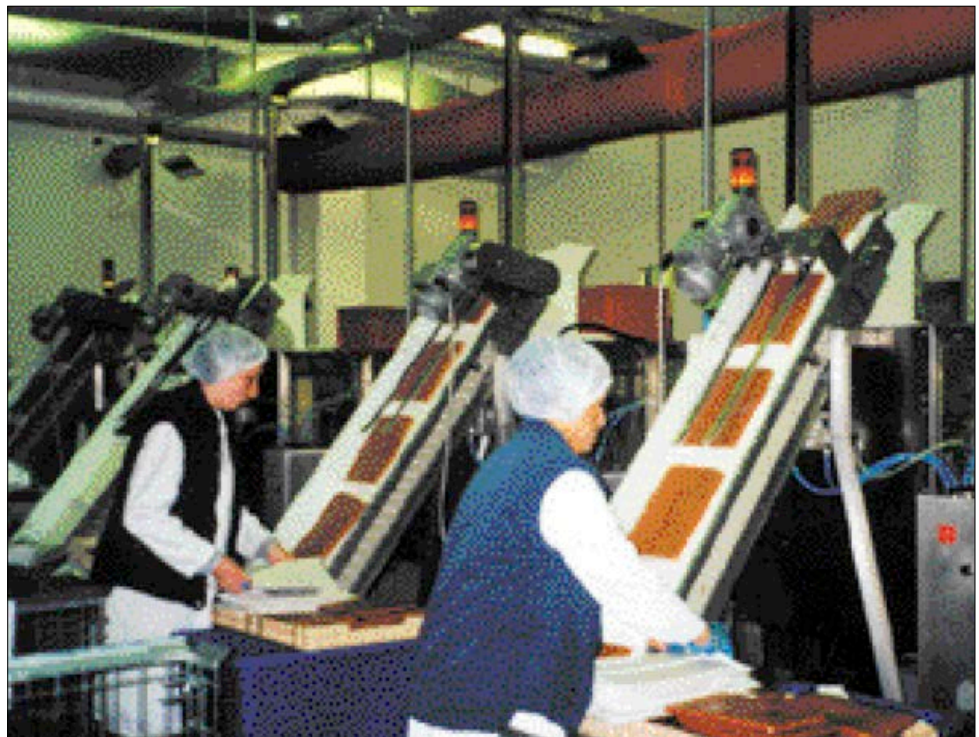
*Solution: plastic chutes for toffee transfer*

The company replaced the metal chutes with plastic chutes.

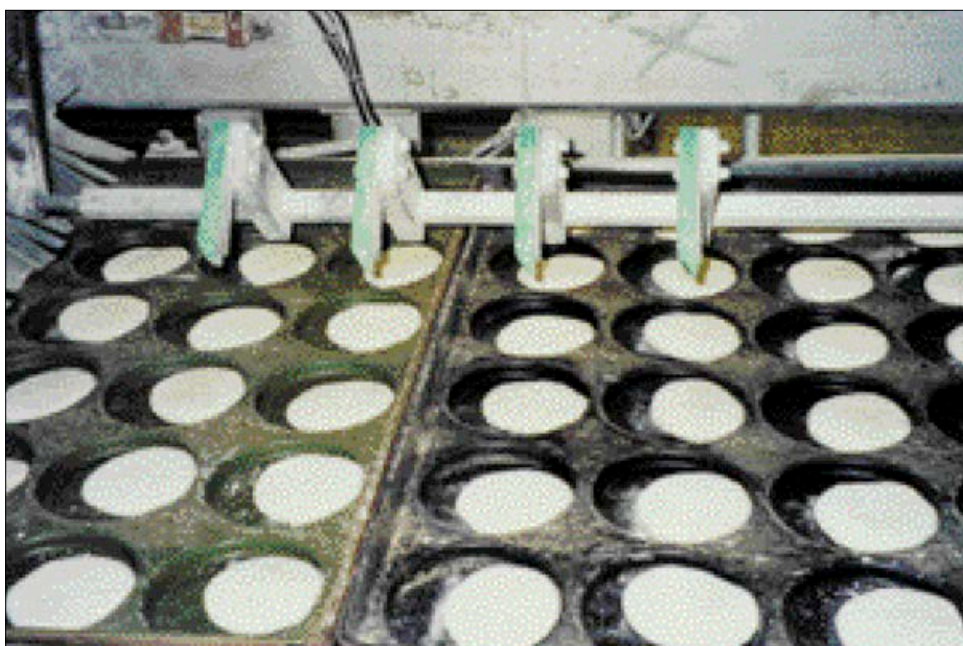
*Solution: tray-indexing arm with plastic-capped fingers*

Plastic (polyurethane) caps were placed on the ends of the fingers of the indexing arm where they came into contact with the trays.

- Noise levels were reduced to 87–89 dB.
- Damage to the surface of the trays was reduced.

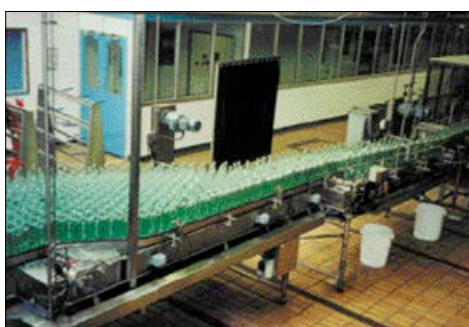
*Solution: new design of conveyor and accumulation table*

- Bottles were banging together as they passed along the conveyors and onto the accumulation tables.
- The noise level associated with this process was 101 dB in places. Operators had to wear hearing protection over the course of an eight-hour shift.

This increased control over the progress of the bottles prevented them from banging together.

- The noise levels for the bottling line were reduced to 84 dB without enclosures.
- Staff were no longer required to wear hearing protection and were happier with the solution.
- The greater bottle control reduced bottle breakages on the line as bottles were no longer travelling under pressure.
- The efficiency of the line was increased as the bottles could accumulate at the end.

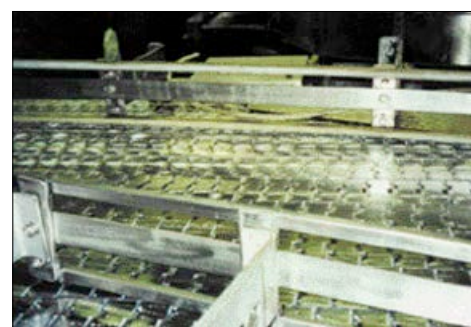
*Solution: close-up of variable speed chains*

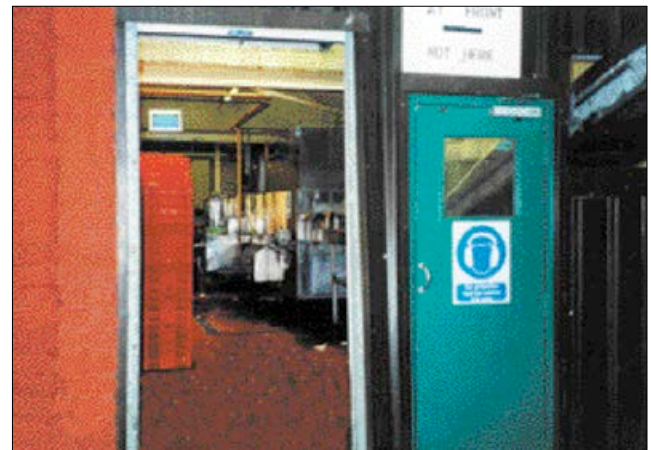
*Solution: basket-washing plant now housed in separate building*

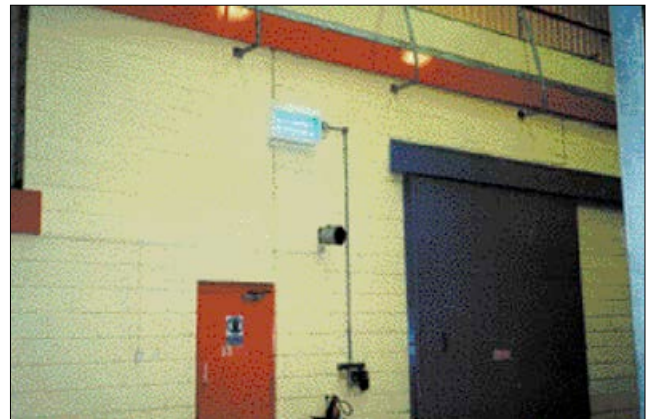
*Solution: entrance to separate room for air-compressor*

The noise levels outside the compressor room were 60–70 dB.

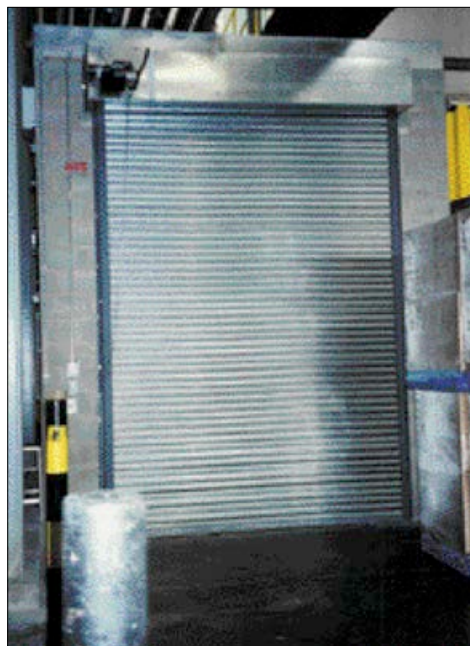
*Solution: entrance to the new segregated enclosure for cap storage and delivery*

With a new production line, consideration was given to the noise levels in the working areas. The location of the cap storage and delivery systems was not critical so the decision was taken to move this process outside of the production bay into a purpose-built enclosure. The enclosure only needed to be visited three to four times per shift.

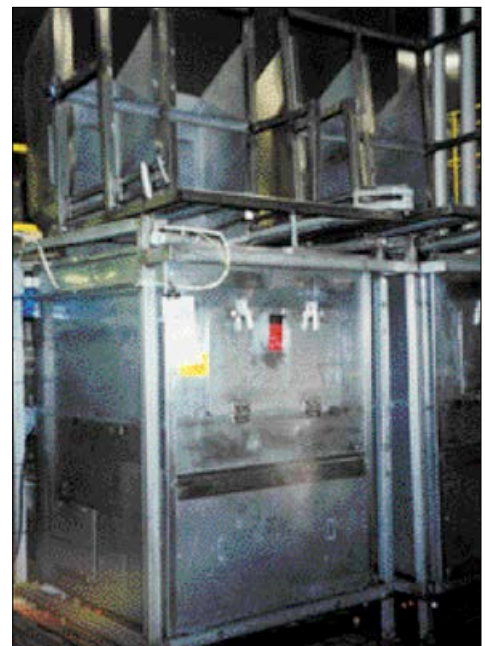
*Solution: stainless-steel cap-hoppers inside new segregated enclosure*

Part of the PET bottling process required the cap closure to be fitted to the neck of the bottles. The caps were fed via airveyors from large, stainless-steel hoppers. Inside the hoppers the caps were continually shaken to prevent jams.

The caps vibrating against the stainless-steel hoppers were causing excessive noise levels.

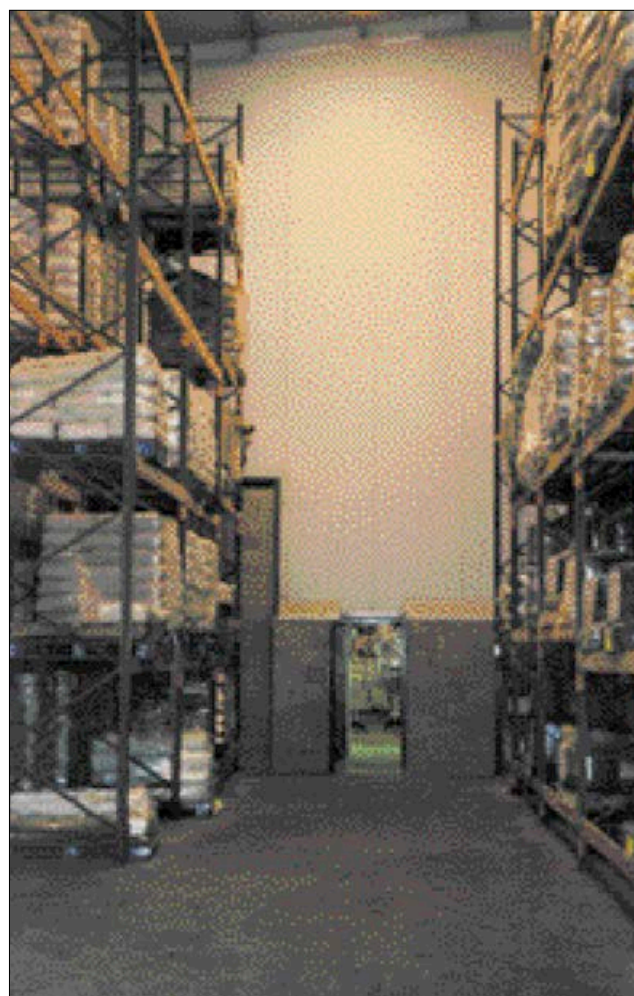
*Solution: new wall lined with acoustic panelling erected between processing area and packaging area*

- Noise levels in the packaging hall were reduced so that hearing protection was no longer required.
- The wall increased hygiene in the factory as it prevented cross-contamination of raw materials and the finished product.

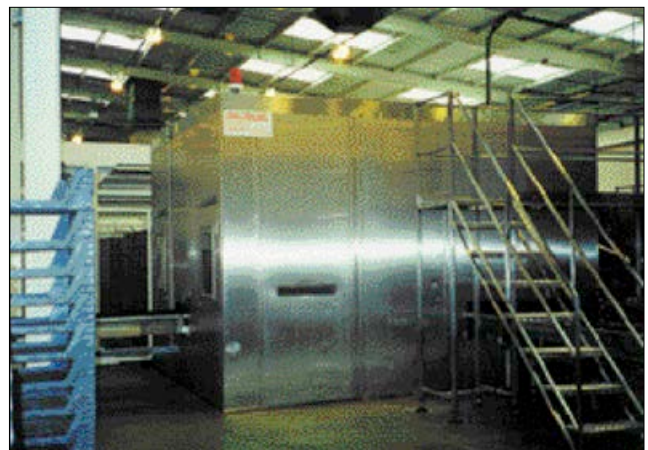
*Solution: soundproof enclosure erected around noisy plant*

Noise levels in the bakery decreased to below 85 dB.

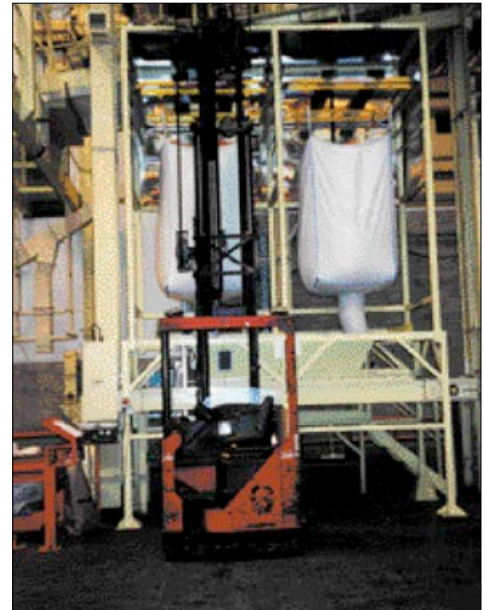
*Problem: one-tonne bag of dried food suspended above original conveyor*

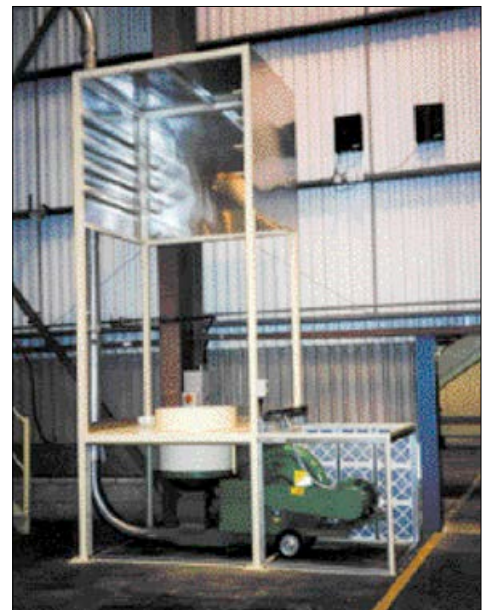
*Solution: new blower machine installed in enclosure (sound-absorbent side panels removed for clarity)*

The company decided to replace the conveyor with a new piece of machinery that would transport the dried food from the one-tonne bag above to the packing machine by blowing it through metal tubing.

- The noise levels produced by the enclosed machine were reduced to below 90 dB and the noise levels in the packing side of the factory were maintained at the same level despite the introduction of the blower machine.
- The new machine was more efficient at delivering the product from storage to the packing machine.

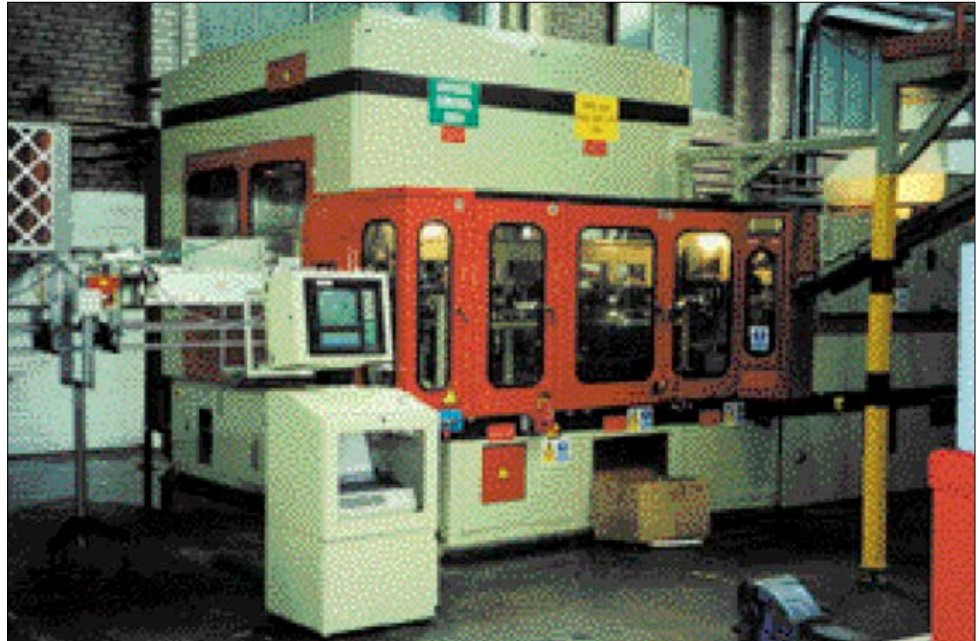
*Problem: bottle-blowing machine in production hall before being relocated in separate room*

The bottle-blowing machines were the noisiest pieces of equipment in the production hall. They produced noise levels of 94 dB.

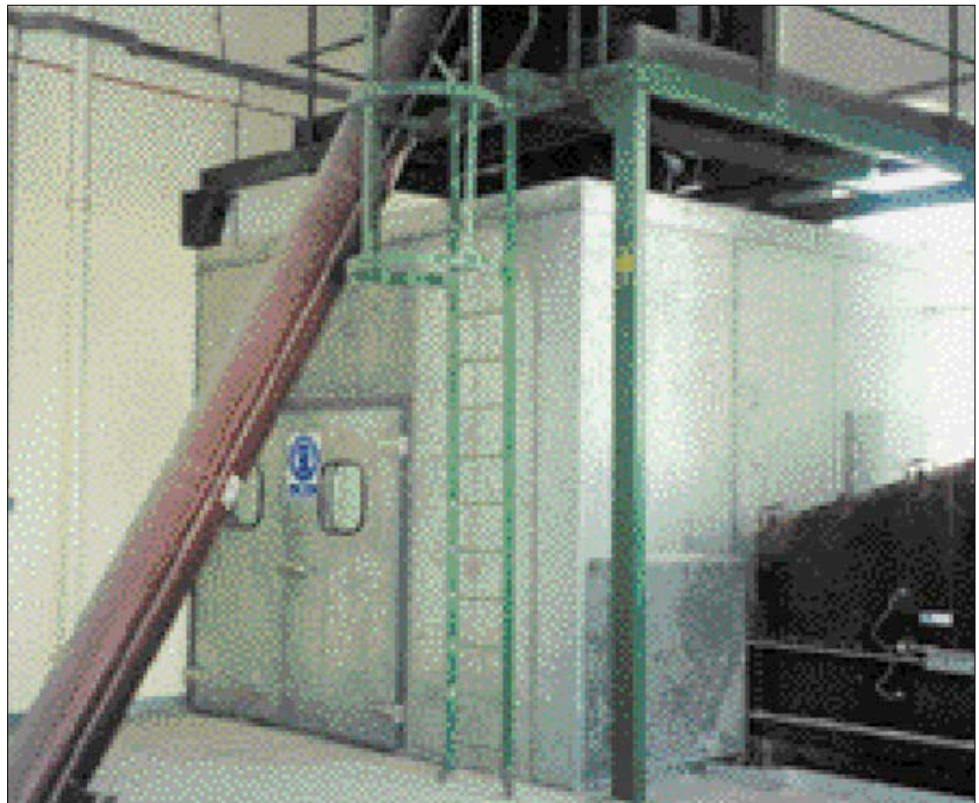
*Solution: hammer mill enclosed in acoustic booth*

At a brewery, a hammer mill was used to crack malt as part of the brewing process.

The company enclosed the hammer mill in an acoustic booth.

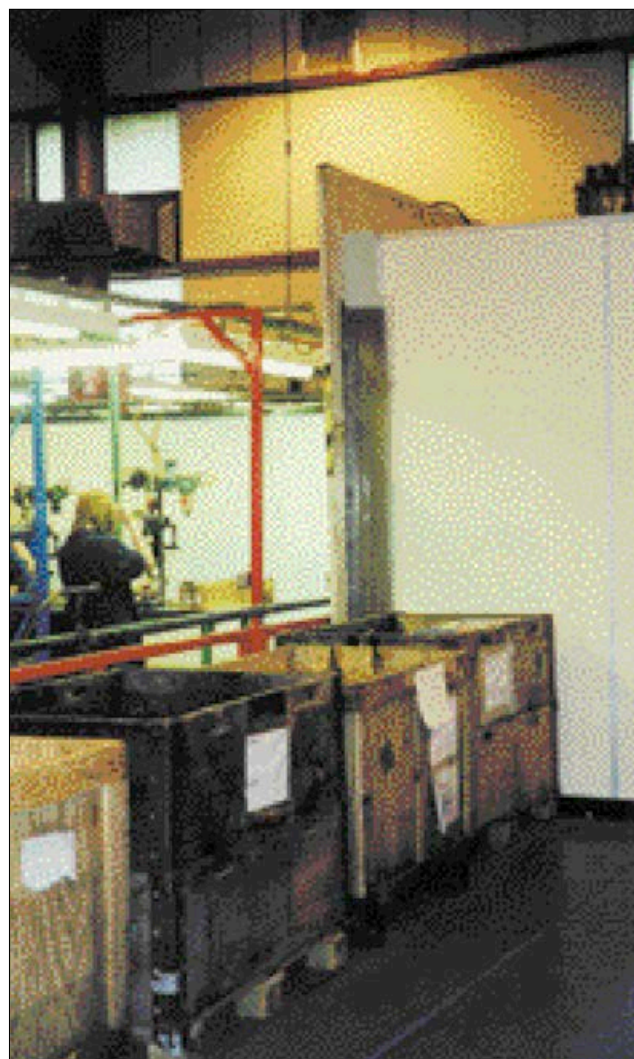
*Solution: new, sound-absorbent steel sandwich wall erected between production area (left) and office (white fabrication on right)*

The noise levels in the office were reduced to 62–63 dB.

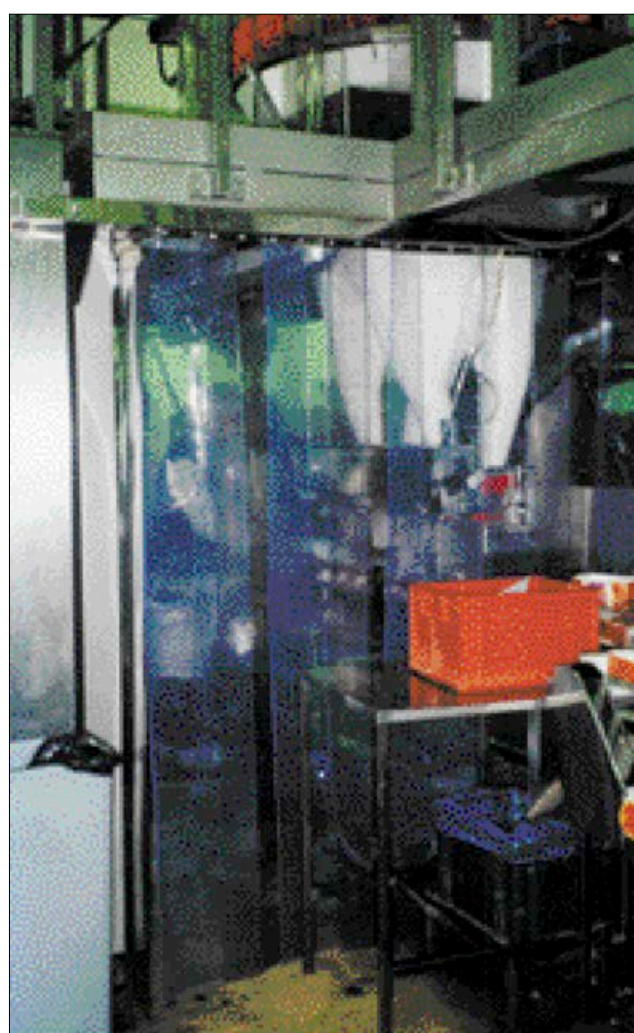
*Solution: flexible PVC curtains fitted around multi-head weigher*

The noise levels in this section were reduced to 88 dB.

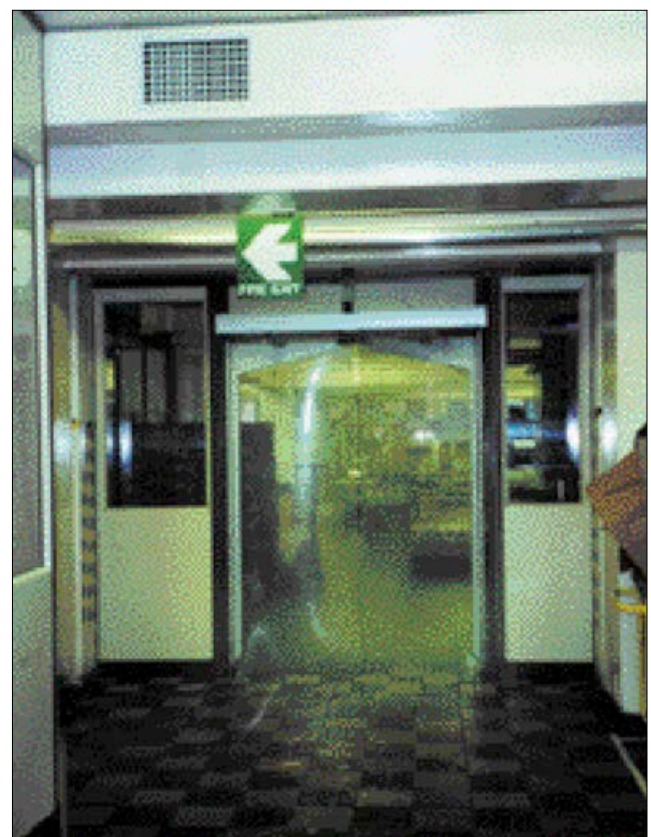
*Solution: automatic, flexible PVC curtain doors installed to segregate ear protection zone from quieter area*

- Noise was reduced in the areas that were not hearing protection zones.
- The sound-deadening properties of the walls were kept intact by the use of the automatic doors.
- The boundaries between the hearing protection zones and quieter areas were made visible.

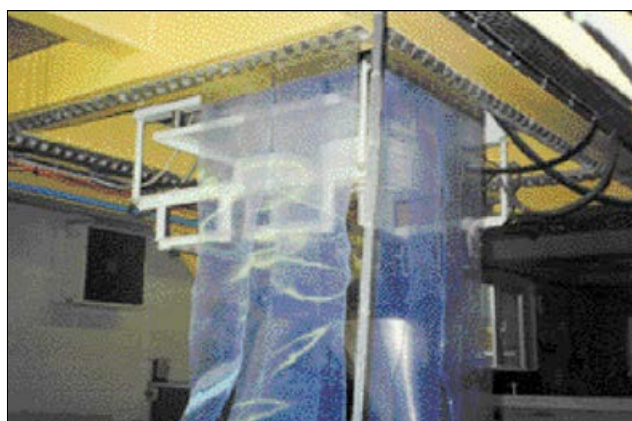
*Solution: PVC curtain enclosure under construction (50% overlaps are required to be effective)*

Noise levels for the hard gum weighing and bagging process were reduced from above 90 dB to around 83 dB.

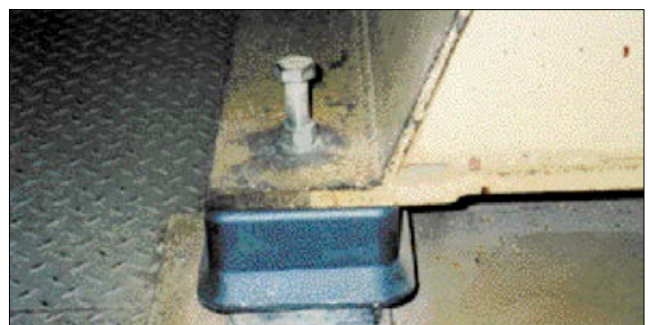
*Solution: close-up of anti-vibration mount*

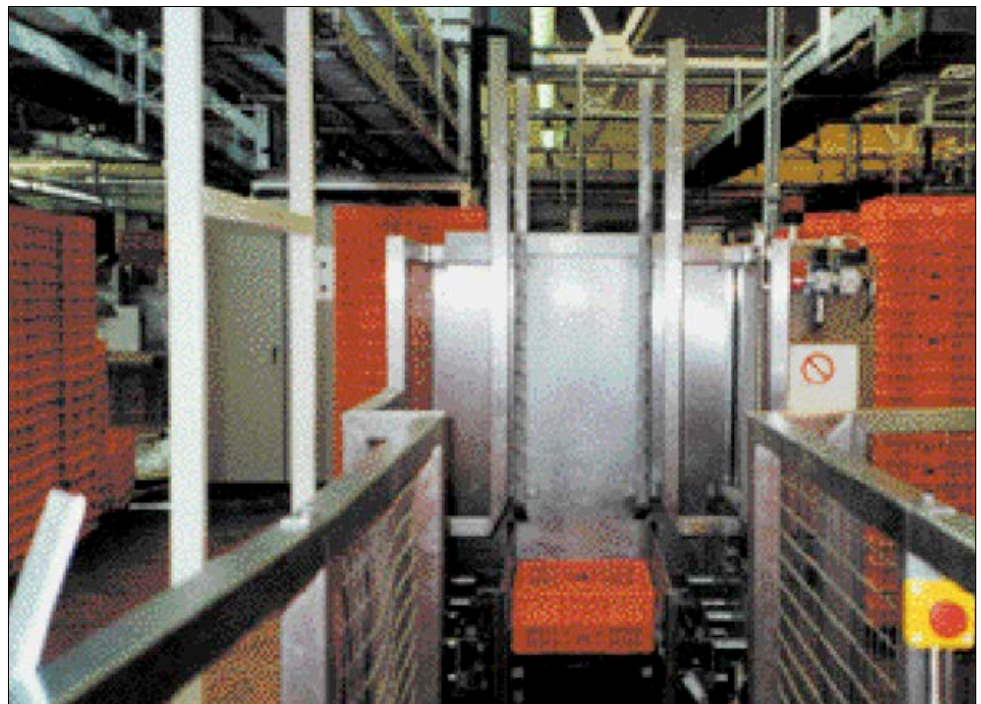
*Solution: bread-baskets in stacking machine*

Working with the equipment manufacturers, the company replaced the hard, plastic caps on the end of the hydraulic dampers with soft, rubber caps at minimal cost.

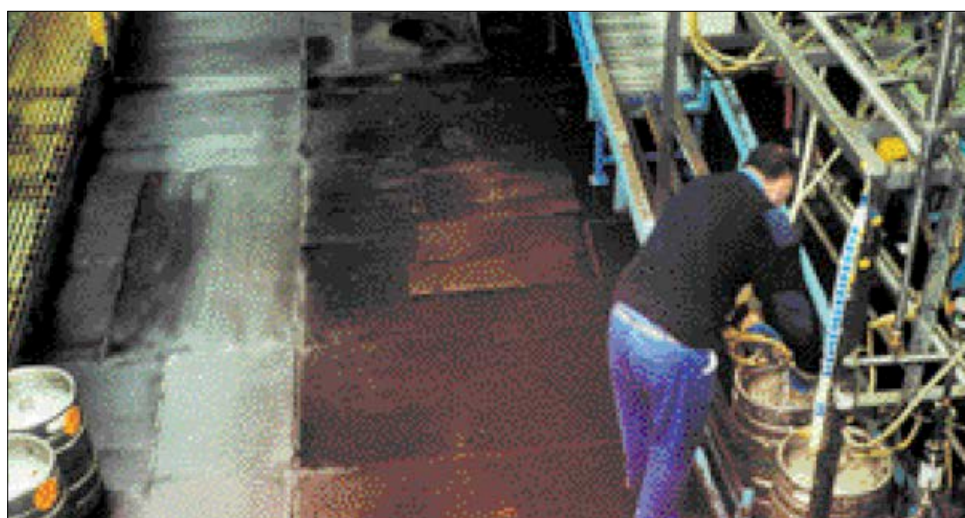
*Solution: rubber matting (black) on floor where kegs are rolled*

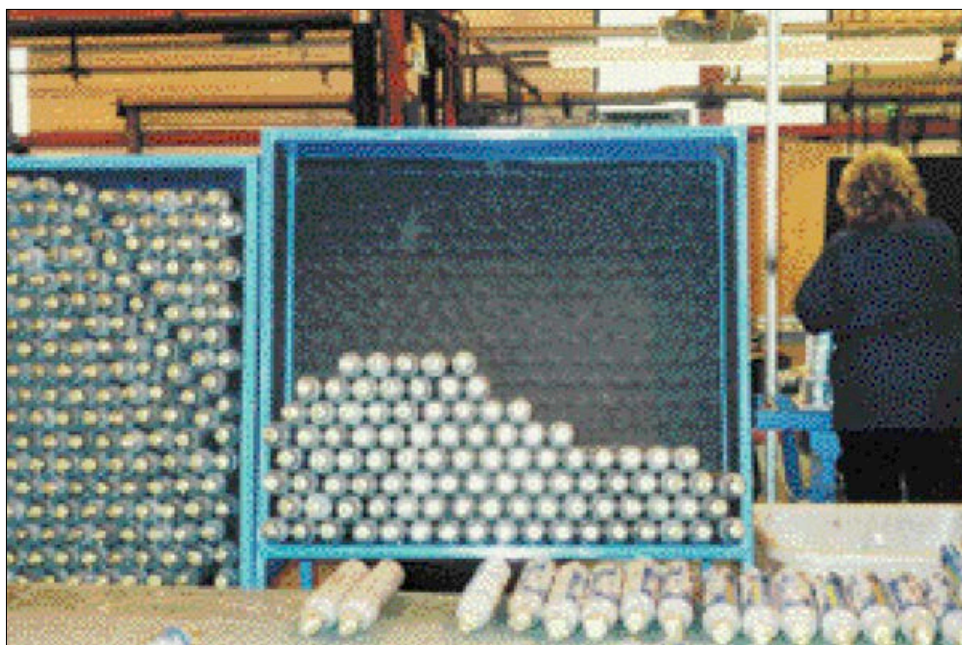
*Solution: rubber matting fitted to back of trolleys to reduce cylinder impact noise*

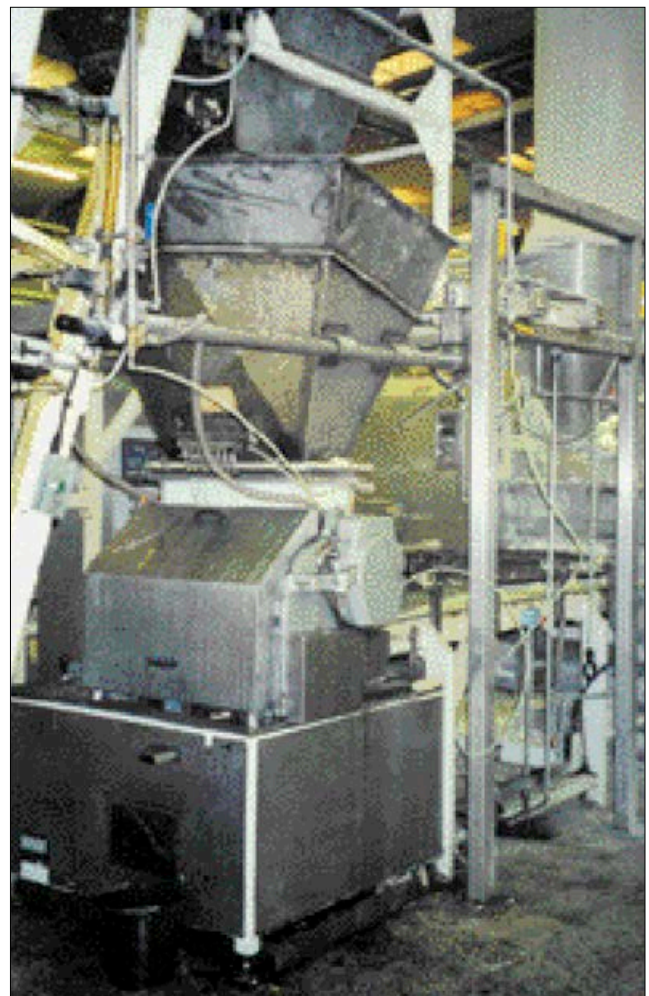
*Solution: mechanical modifications on dough mixer halved noise level*

- Bearings on the machine were replaced.
- Loose panelling around the base of the machine was replaced by new, close-fitting aluminium sheeting, which resulted in less vibration and consequently less noise.
- Compressed air exhausting from the mixer was also reduced.
